Protection of Side Slopes of Drain in West Nile Delta: Case Study

Marawan Shahien¹, Ahmed Farouk² and Ahmad Daif³

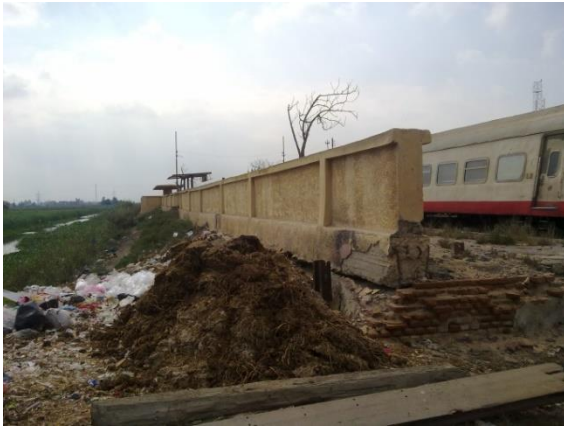
Figure 2 : Abu Hummus Drainage failure 01- Sahaly

It also led to the inefficiency of industrial works (Coverage, Culvert, Several bridges, Siphons, and others) Since the drainage passes through many residential blocks, it is exposed to many sources of pollution, especially with pre-treated or untreated wastewater, and also dumping solid waste (garbage and agricultural waste) on its sides. These and other reasons led to several Side slope failures of the drainage. Figure 2,3

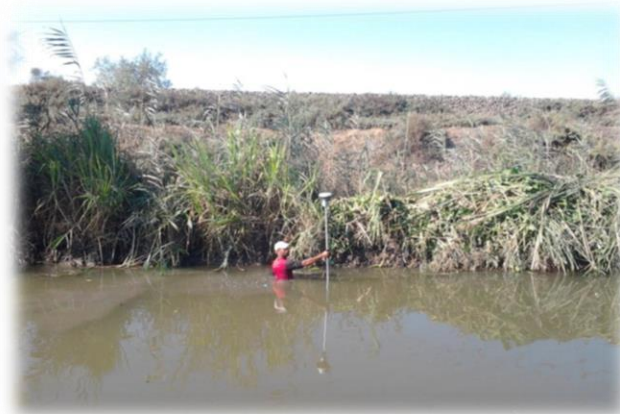
Figure 4 : Surveying works of Abu Hummus Drainage sectors

Surveying the actual cross sections of the drain from the beginning to the downstream was done three times periodically every two months with an intersectional distance between 1000 to 2000 meters, in order to assess sedimentation or erosion rates and their relationship to time along the path of the drain. Figure 4

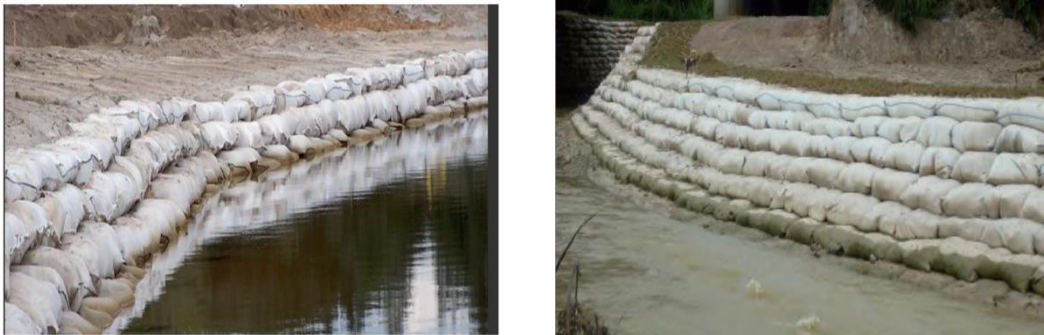
The Drainage Research Institute has provided a method of protection which does not result in any negative effects either on the left embankment of the drain or the right embankment and the railway lines, it was geotextiles filled with sand. Figure 11

Figure 11: Pictures of some projects implemented with geotextile bags reinforcing the tendencies of the channels

The design method was based on reducing the water duty to 17 m³ / f / day instead of 33 m³ / f / day, resulting in a reduction of the water sector area and a decrease in the width of the design bed by one meter on average. The drain axis has been moved to the right side by a reduction in the bed width of one meter on average, which will help to increase the stability of the railway

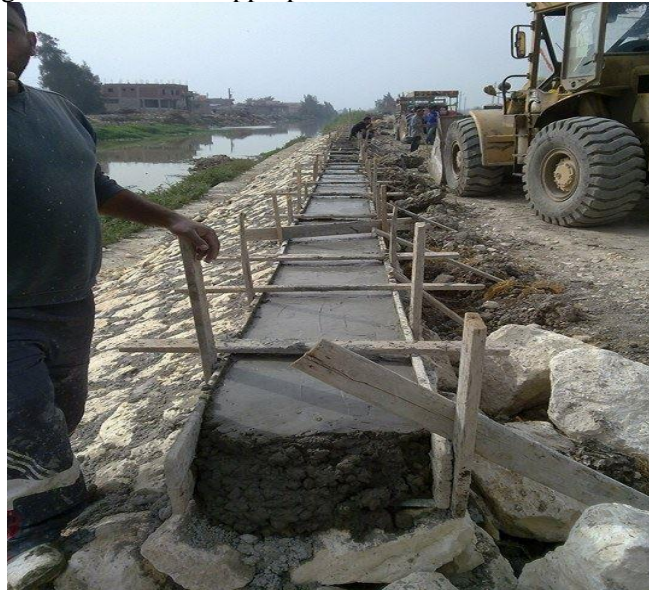
Figure 16: Pictures of some projects implemented with **Soldier Pile Walls**

It consists of aligning mechanical Strauss piles with a diameter of 0.40 m at distances from 2.5 to 3.0 m with a depth of not less than one and a half times the free length of the pile with an armament of 8 Ø 16 and spirals strips every 0.15 m. Connected by a pile cap from the top with a thickness of 0.50 m and a width of 1.20 m. A curtain wall with a thickness of 0.25 hangs from it and its height is not less than 1.0 m. A rip rap with a thickness of 0.50 m is formed above it, reaching the road level, and above it plan concrete beam a thickness of 0.2 m. And installing filters behind the rip rap at the seepage line with clean soil backfilling with gravel behind the failure, as shown in Figure 17, 18.

This method was not feasible as it was previously implemented in some failure places and there was a collapse of the sector where the piles slipped their great spacing as shown in the Figure 19

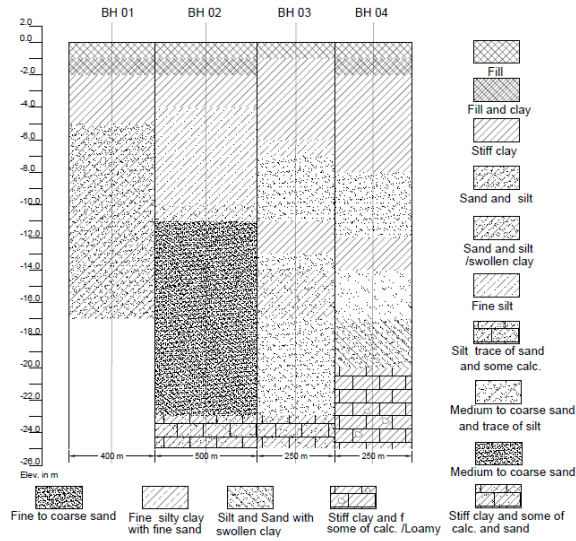
Figure 20: Another soil profile at places of slope failure the Abu Homs drain

At places of failure an another mechanical rotary poring samples taken at a depth of 20 meters, and disturbing and non-disturbing samples were extracted for each one accumulated in the soil profile. Figure 20
