Experimental Investigation of Cyclic Performance of Slotted RC Beam-Column Connection

Mohamed A. Sakr¹, Ayman A. Seleemah², Tarek M. Khalifa³, and Esam A. Darwish⁴

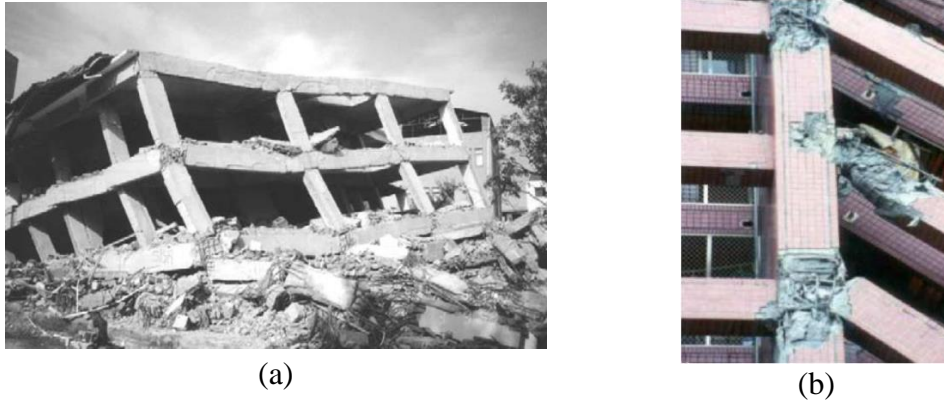
Fig. 1 (a) Collapsed building from the August 17, 1999 Kocaeli Earthquake [5] (b) Damage to 15-story building in the September 21, 1999 Chi-Chi Taiwan Eq.

Past earthquake observations and subsequent laboratory works proved that beam column connections have a key role in reinforced concrete (RC) structures, as it is responsible for maintaining the integrity of the whole structure, determining the ductile/nonductile, and strength degradation behavior of moment frames. Failure of such connections can result in a global structural collapse, Fig. 1. Inadequate shear resistance of beam-column joints is one of the most severe deficiencies in RC frame structures that make it vulnerable against earthquakes, Fig. 2 , [1-3].

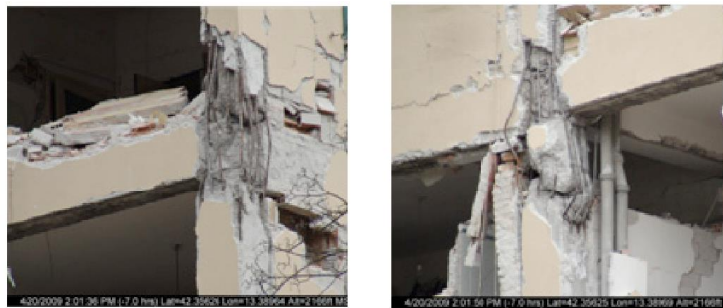
Fig. 2 Severe damage in beam column connection in RC building, L'Aquila Earthquake, Italy -2009. [3]

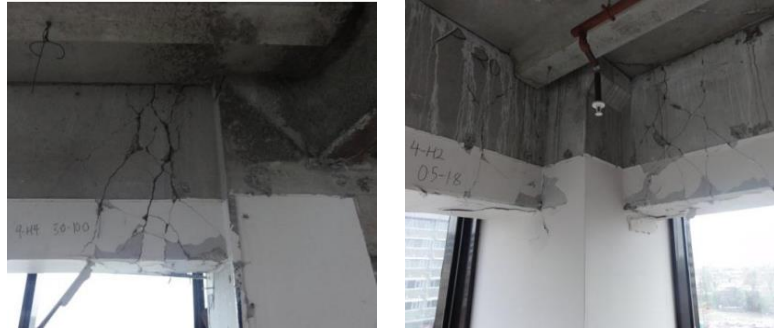
Fig. 4 Damage of ductile Beam Column Joint at the Price Waterhouse Coopers Building-New Zealand at 22 Feb 2011 Christchurch earthquake [6]

The first consequence is damage to the structural elements. The cracking of concrete necessitated to provide adequate ductility means that at the end of a significant seismic event the plastic hinge zones are heavily damaged, such as shown in Fig. 4. Following the 1995 Kobe and 2011 Christchurch earthquakes there were examples of buildings that had formed plastic hinges, as designed, being demolished due to prohibitive rehabilitation costs [6].

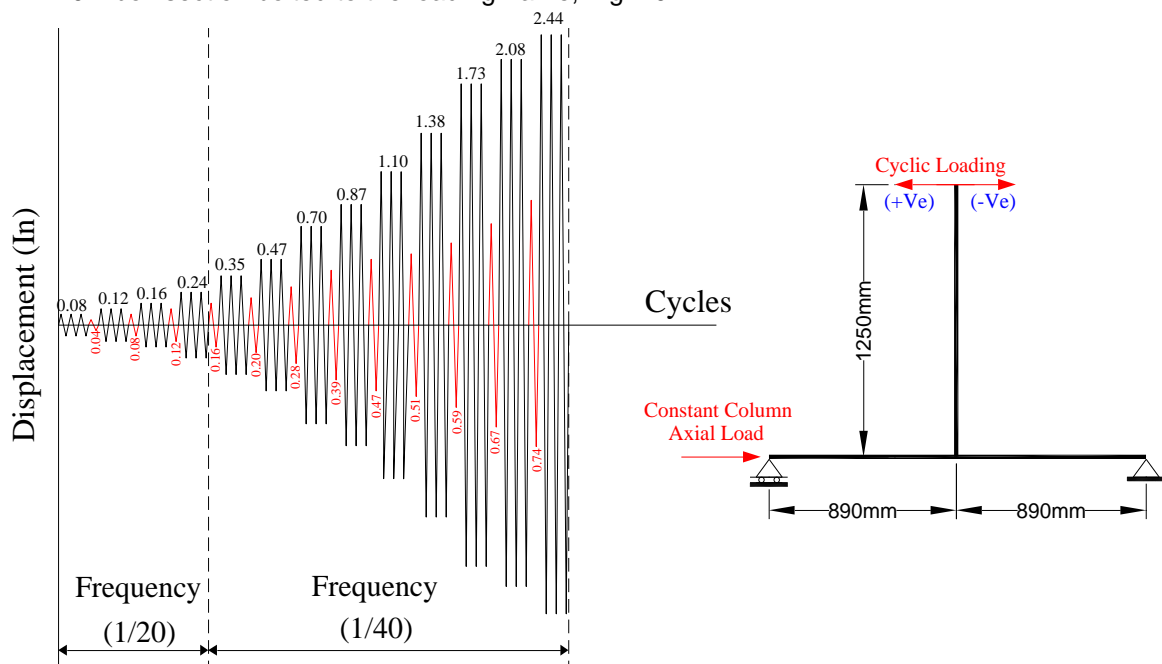
Cyclic quasi-static loading was used to simulate seismic action on beam column connections. A displacement-controlled loading system was used which applied increasing displacement until a specified displacement ratio was reached. The drift sequence in Fig. 9 was applied at the beam tip in accordance with American Concrete Institute (ACI) acceptance criteria for moment frames (ACI Committee 374, 2005). Test specimens were subject to 3 cycles at displacement ratio levels of 0.16%, 0.24%, 0.32%, 0.48%, 0.71%, 0.95%, 1.42%, 1.76%, 2.22%, 2.80%, 3.50%, 4.20%, and 4.94%. Smaller cycles, varying from 0.67 to 0.33 of the previous displacement, followed each large displacement set to close gaps between aggregates in the concrete. According to ACI 374.1-05, there is no obligation for an axial load to be applied to the column simultaneously with the application of the lateral displacement. However, a constant axial load

Fig. 9 Quasi Static Loading Protocol

of 1340 lb (60 kN) was applied to the column, using hydraulic jack, this load was to prevent any movement of the specimen during the test, Fig. 9.

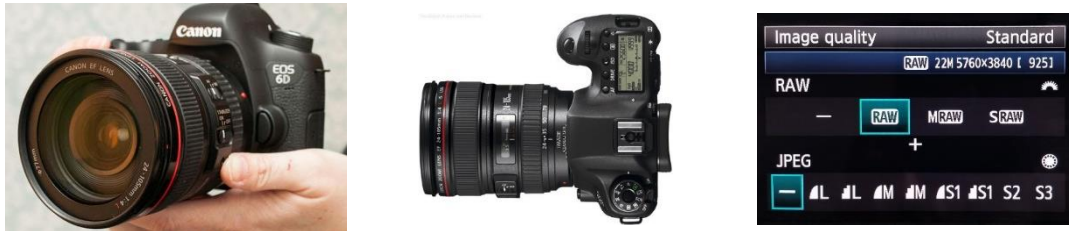
(a) Region of interest (ROI) and applied speckle pattern on the specimen frontside face

(b) Camera used for DIC

Fig. 12 Region of interest (ROI), applied speckle pattern, and camera settings for DIC

On the frontside face of the specimen, digital image correlation 'DIC' was used to calculate complete surface displacement and strain fields of the specimens under test loading. The region of interest 'ROI' was first identified and a random speckle pattern with high contrast (black speckles over white paint) was applied to the specimen, as shown in Fig. 12a. Using Canon EOS 6D digital camera with Canon zoom lens EF 24-105mm 1:4 L IS USM and the focal lens

was adjusted to 50mm, 312 high resolution digital images were taken during the evolution of the test loading. The quality settings of the camera were adjusted to get RAW images with heights quality, Fig. 12b. Camera Setup for the test is shown in Fig. 11. The software package **Optecal** was used to process the images for the DIC. For more details on the DIC technique.

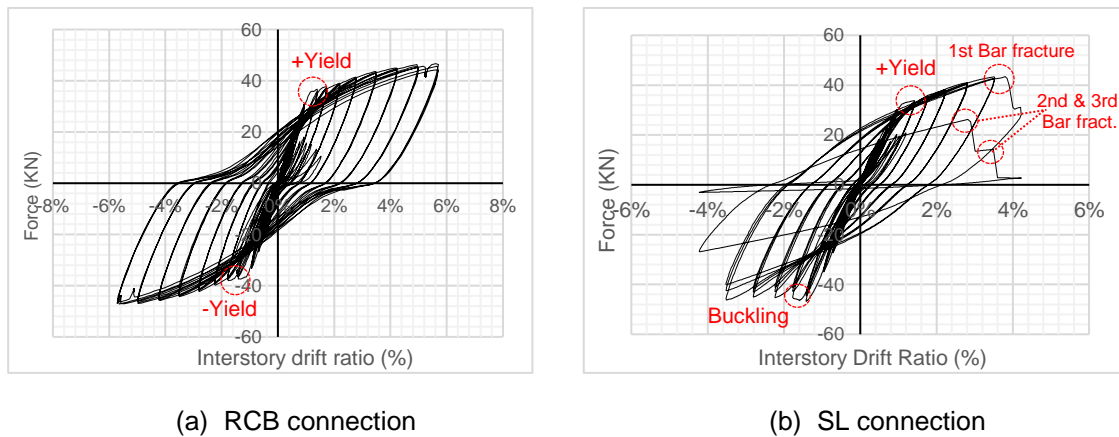
Applied force versus drift ratio response for the conventional beam column connection RCB and slotted connection SL are shown in Fig. 13. Fig. 14 shows the drift ratio versus beam shear sliding of the different test modules. As shown in Fig. 13, a stable, typical reinforced concrete hysteresis up to 5.6% drift ratio. Pinching of the hysteresis curve because of beam shear sliding was first observed at 1.71% drift ratio (0.85in) at 37 KN applied force as shown in Fig. 13 and Fig. 14. A much fatter steel-like hysteresis curve for the slotted connection SL compared to the conventional connection RCB. This can be explained by the very small value of beam shear sliding compared to the conventional connection as shown in Fig. 14.

Fig. 13 Hysteresis curves of test specimens

Yielding of beam bottom longitudinal reinforcement in tension for RCB was observed at 1.10% drift ratio (0.56 in), at an applied force of 35.4 KN, Fig. 13 a, while yielding of beam top longitudinal reinforcement was observed at -1.20% drift ratio (-0.616 in), at an applied force of -35.58 KN in closing direction, Fig. 13. For SL connection, yielding of bottom longitudinal reinforcement in tension was observed at 1.10% drift ratio (0.56 in), at an applied force of 33 KN which is a little lower than RCB, while yielding of top longitudinal reinforcement was observed at -3.10% drift ratio (-1.53 in), at an applied force of -42.2 KN in closing direction.

Fracture of beam bottom reinforcement due to low cyclic fatigue was first occurred at cycle number 45 at +3.80% drift ratio (+1.87in) at +43.36KN for one of the three beam bottom rebars resulting in a sudden loss of the beam flexural resistance loss by 13.11 KN which is about 30% of the beam resistance at this stage, Fig. 13 b. In the next opening cycle, cycle number 46, at the same time, fracture of the remaining two rebars was occurred resulting in a total loss of the beam flexural resistance, Fig. 13 b and Fig. 17. Because the behaviour of the slotted connections in opening and closing moment is governed by yielding of the lower beam reinforcement, like the conventional connections, the ultimate load capacity of SL-120 at the maximum reached drift ratio in opening direction is almost the same of RCB, Fig. 13.

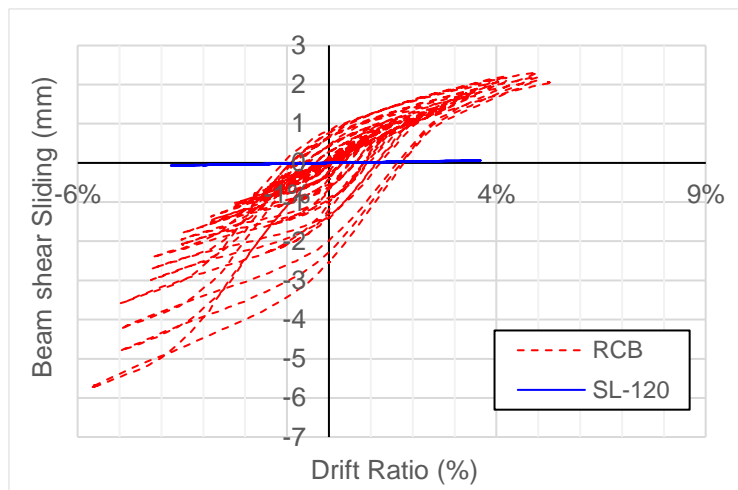
Fig. 14 Drift ratio - Beam shear sliding relationship.

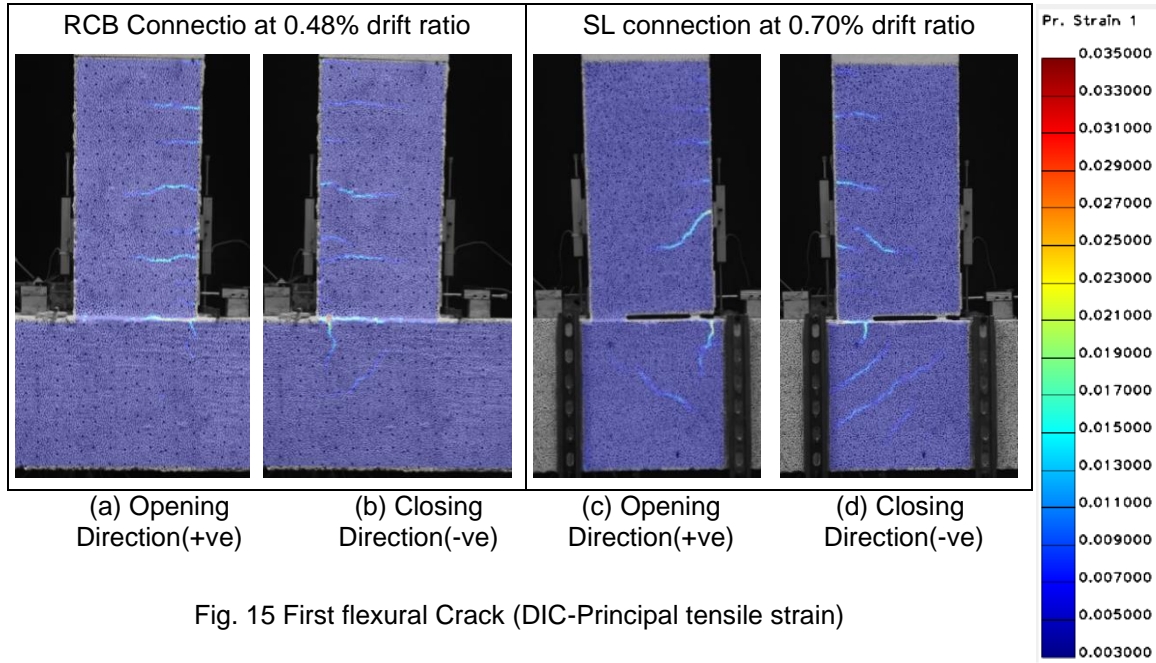
For RCB, first flexure crack occurred at 0.48% drift ratio (0.24 in) at 17.33 KN applied force in the positive direction (opening moment) as shown at Fig. 15 a, while it was occurred at -19.76 KN applied force in the negative direction (closing moment) as shown at Fig. 15 b, and followed by penetration crack inside the column around the beam top longitudinal reinforcement at the same applied load and drift ratio, Fig. 15 b. For the slotted connection, SL, compared to RCB, first flexure cracks in opening and closing directions occurred at higher drift ratios at +0.71% drift ratio (+0.35 in) at +24 KN applied force (opening moment) and -26.61 KN applied force in the negative direction (closing moment) respectively, about twice the corresponding value of

Fig. 15 First flexural Crack (DIC-Principal tensile strain)

drift ratio of RCB, accompanied by longitudinal top and bottom reinforcement penetration crack at the column, Fig. 15. For RCB, Joint diagonal crack was first observed in closing direction then in opening direction at the same drift ratio as SL connection at 0.71% drift ratio (0.35 in) at 36.6 KN applied force.
