# Prioritization of Heritage Buildings in Historic Cairo for Restoration Funding

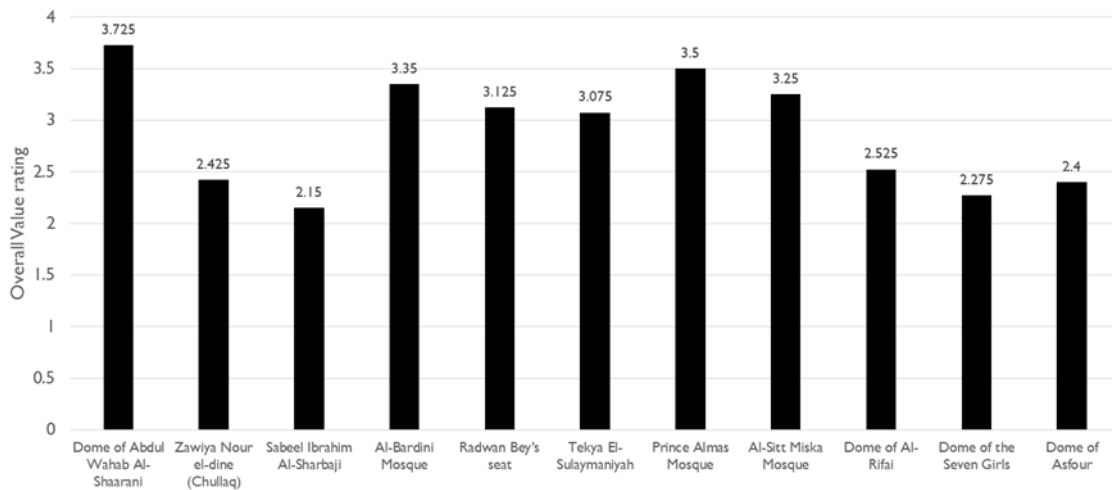
**Fig.3: Overall Value Rating of each structure**

To compute a value for each structure using the aforementioned method “weighted score method”, experts in the domain have been asked to: 1) assign a weight  $W_c$  to each value criterion, and 2) evaluate each structure with respect to each criterion by assigning a value rating  $VR_{c_i}$  with respect to the developed scale shown in Figure 2. To facilitate computations, an average value for the expert’s input has been calculated. It has been noticed that the Architectural value has arguably the highest weight of 25% followed by the historic value with a weight of 20%; while, the age, accessibility and geographical location values were assigned the least weight of 5%. This could be explained, that usually decision makers consider the characteristics of the structure rather than any other gains from the conservation work. Figure 3 illustrates the overall value of each structure, where it can be noted that Mosque of Abdel-Wahab El-Shaarany has the highest overall value, followed by Mosque of Prince El-Mas and El-Bardini Mosque. This could be explained by the high values that Mosque of Abdel-Wahab El-Shaarany received in the survey with respect to the religious and political values, as many prayers are being held there. On the other hand, Sabil Ibrahim El-Shorbagy has the least value, as it scored quite low in most of the criterions. It should be noted as well that the results of this task will be further validated, using the opinions of several experts. In addition, since the architectural value has the highest weight in terms of influence in the overall value of the structure, detailed architectural assessment will be conducted as well, as part of the future works.

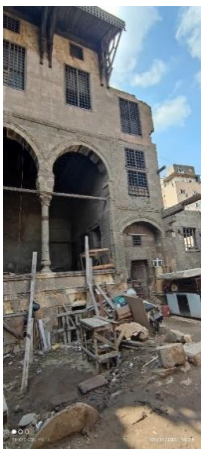
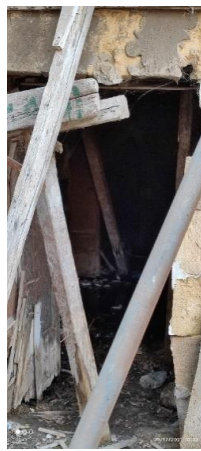
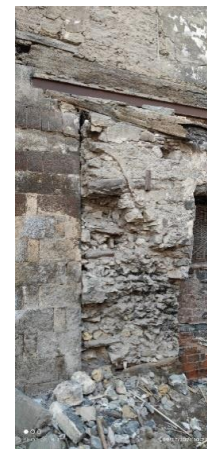
**Fig.4: Condition of Maqid Radwan Bey**

(a) General view of the structure.

(b) Signs of dampening and high ground water table.

(c) Signs of deterioration and missing parts.

shows a sample of the photos taken during the visual inspection of the condition of Maqid Radwan Bey, where it shows signs of severe deterioration and signs of dampening on the walls due to high underground water table.
